# INDOOR AIR QUALITY INVESTIGATION

**BENTON ELEMENTARY SCHOOL  
1410 HINKSON AVENUE  
COLUMBIA, MISSOURI**

**Contract C-23018  
January 2023**

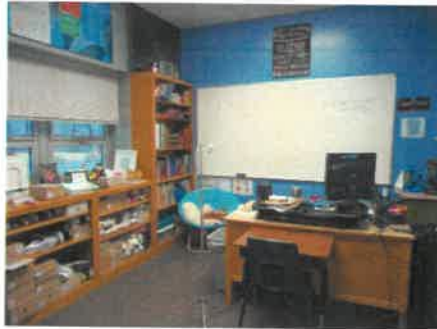
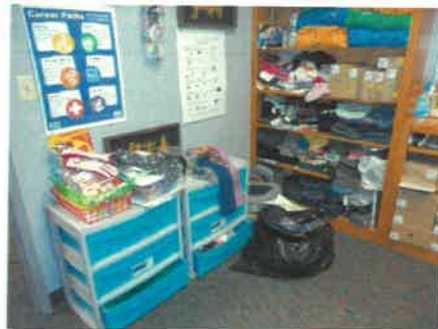
- The Home School Coordinator's office was identified as occupied by an employee with health concerns. This office appeared to be clean and in good condition, with no visible mold observed. Wooden shelves located

along the perimeter wall prevented observations of that wall. A large amount of clothing and shoes is stored in this office.

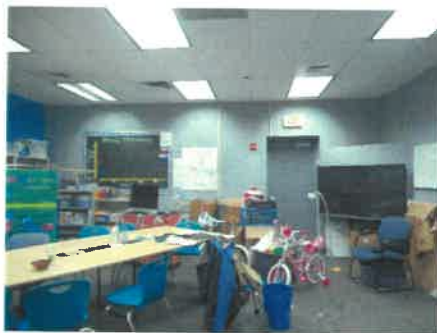
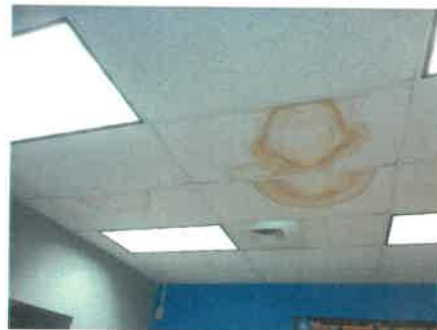
- The Home School Coordinator's office opens into the Computer Lab/Office. This area appeared to be clean and in good condition. Several ceiling tiles show isolated areas of water staining from roof leaks through roof fasteners and missing roof flashing; however, no suspect mold growth was observed on the tops of the affected tiles.

- Stained ceiling tiles in a few locations in the areas tested are likely the result of small leaks from roof fasteners and missing flashing.
- Exterior wall caulk around windows and at expansion joints is missing in some locations.

- Repair roof leaks, replace missing flashing, and recaulk around windows and expansion joints to eliminate routes of water intrusion. Following completion of repairs, replace water-stained ceiling tiles.
- Verify and adjust if necessary the amount of outdoor makeup air from the HVAC units to increase relative humidity levels. Supplemental humidification may be necessary during heating season, as low humidity levels may decrease occupant comfort levels.
- No additional investigation or air sampling is recommended.

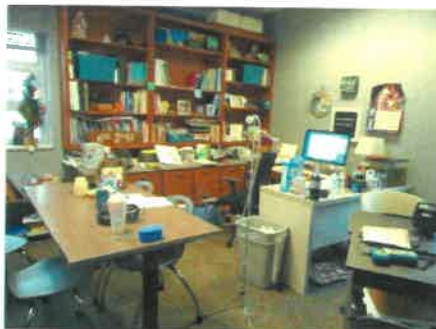
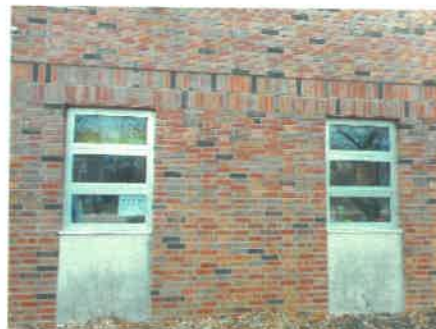
- The Principal's office is located in the administrative office suite. This area appeared to be clean and in good condition. Caulk around exterior windows of this office (and other windows and expansion joints) is damaged or missing.
